Two Approaches to Rehabilitation of Metal Roofing at Wheeler Army Airfield Hawaii

Dave Bailey

U.S. Army Corps of Engineers,
Engineer Research and Development
Center

Construction Engineering Research
Laboratory
Champaign IL

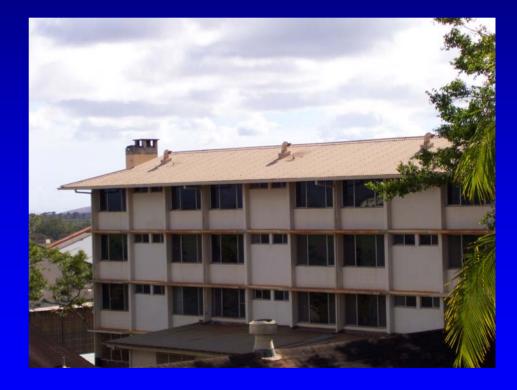
Building 118 - Barracks

- Corrugated metal panel
- **2**0,000 SF
- 15 + years old

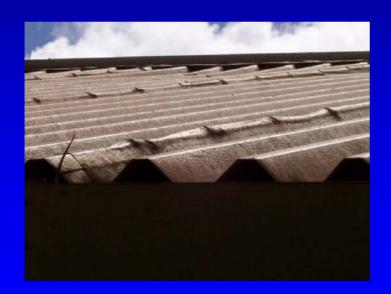
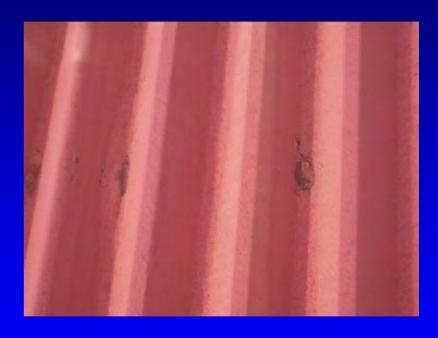
Existing Conditions

- Overlay with coating
- Some rusting
- Persistent leaking

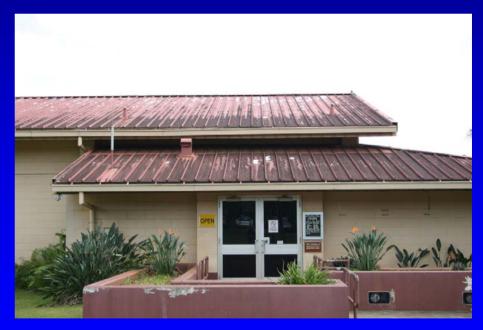
Building 835 – Bowling Center

- Standing seam metal roof
- 10,000 SF
- 22 years old

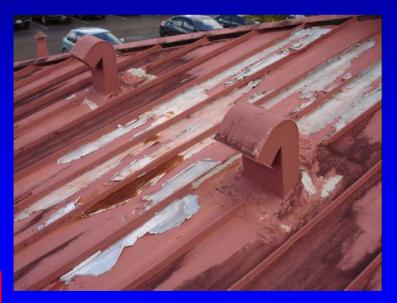
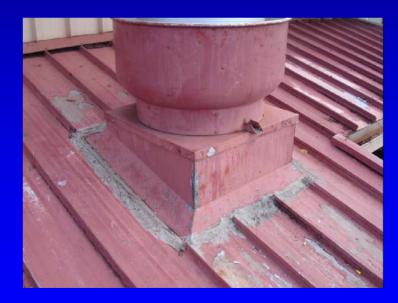
Existing Conditions

- Severe paint delamination
- Areas of rusting on panel surfaces
- Poor detailing of roof penetrations
